### Summary of Issues Found or Discovered

# XPERT Home Inspections

Example of Summary Report

Sample Address, Decatur, Alabama

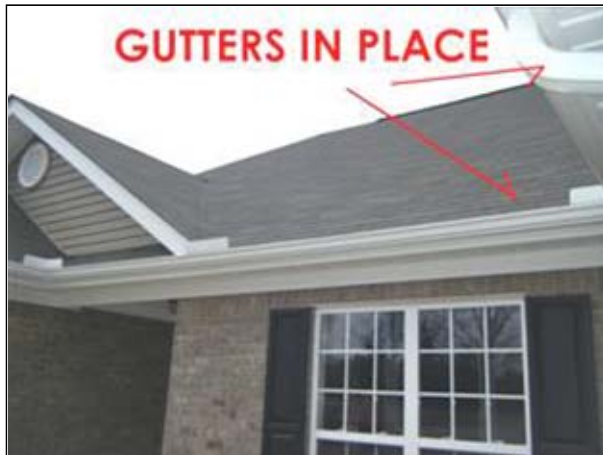
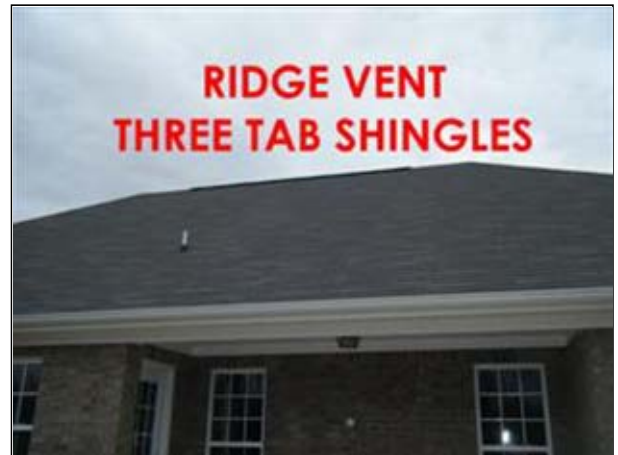
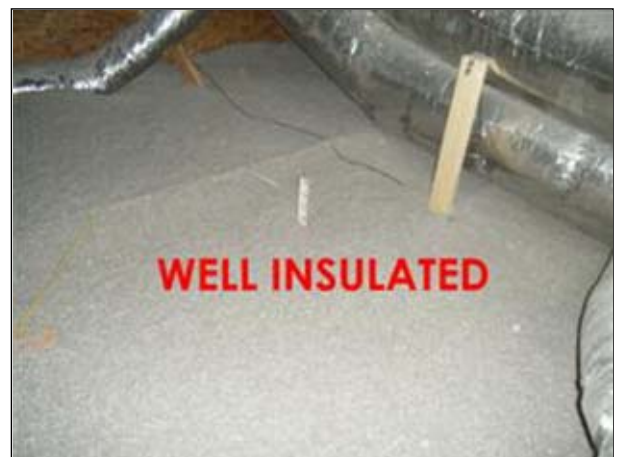
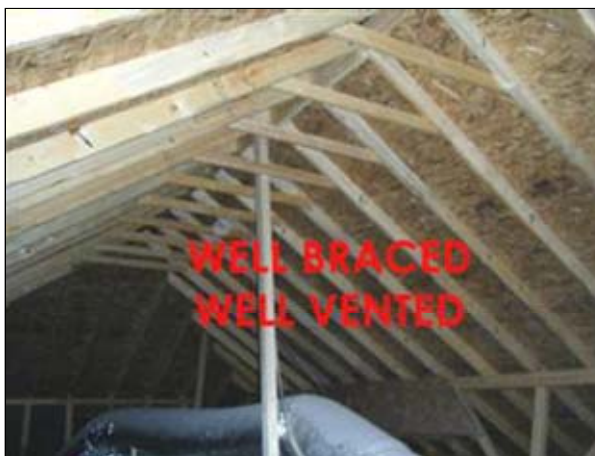
1. The roof is in good condition and gutters and downspouts are in place. A ridge vent provides adequate venting, the attic is floored and lighted for storage and it is well insulated. The roof structure is stick built and conforms to published standards and it is well braced.

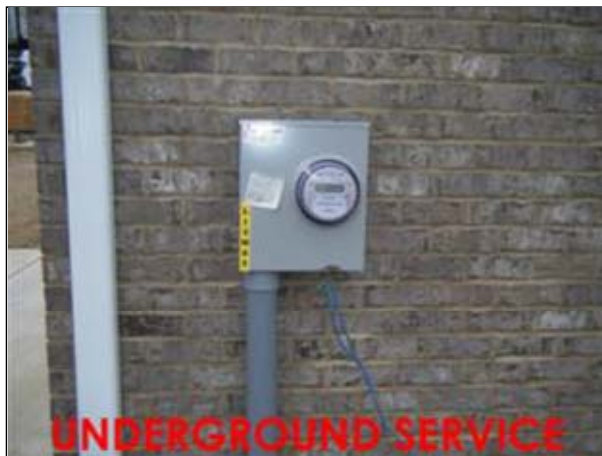
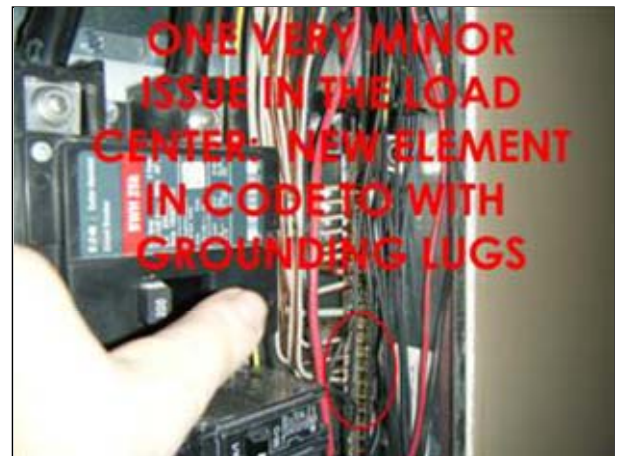
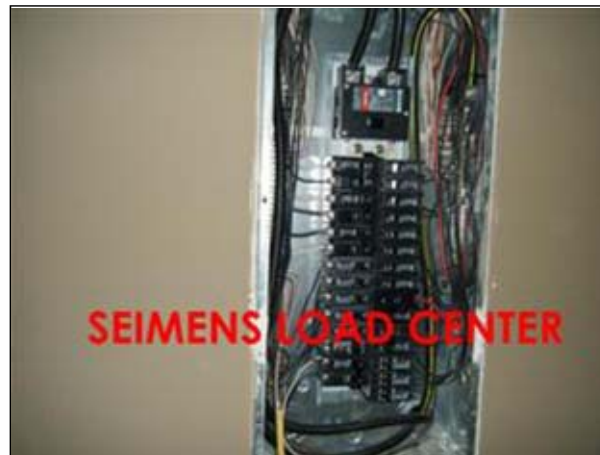
1. The underground electrical service based system is in good condition and conforms to all codes that are enforced by the local enforcement area. I pointed out to the builder a small change in

codes that could be improved inside the load center at no charge and he advised his electrician to make the changes.

2. GFCI outlets are in place and the home has ample smoke detectors.

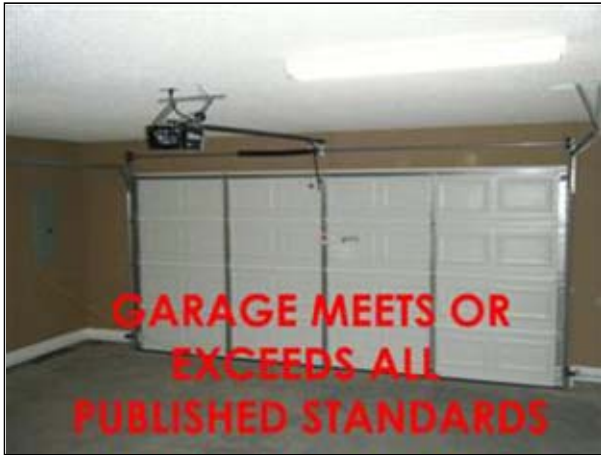
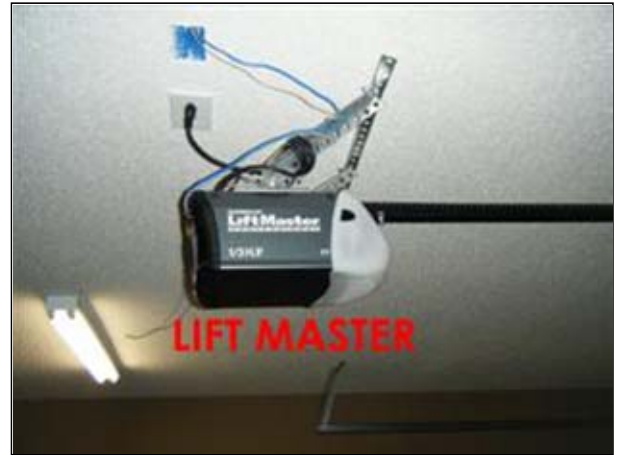
1. The garage meets all safety recommendations and the garage door is installed with the proper safety elements in place. The garage walls and doors form a fire wall for your protection. The hot water heater is elevated to prevent spark/vapor ignitions and the bricks form a crash post to protect the water heater from possible damage from a car.

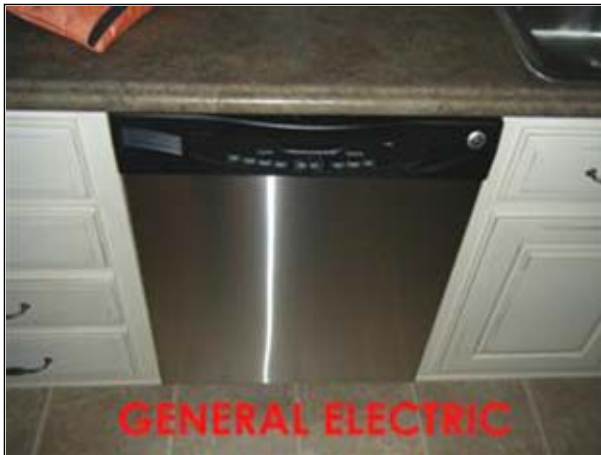
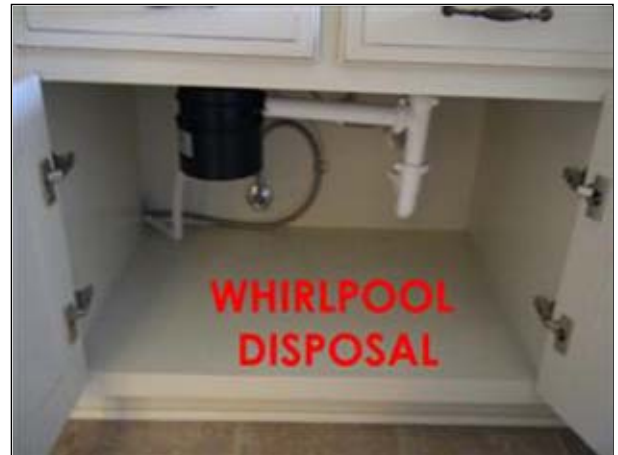
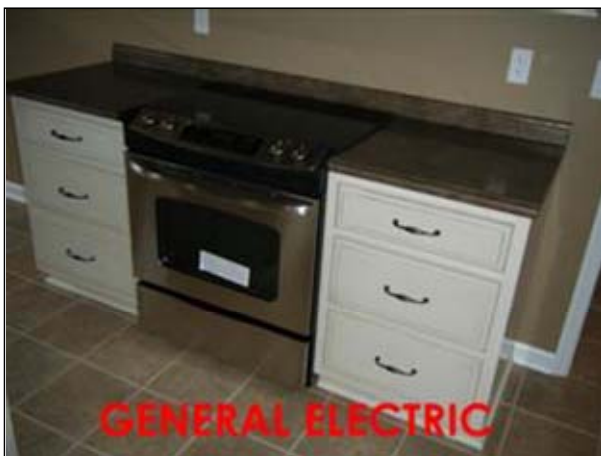
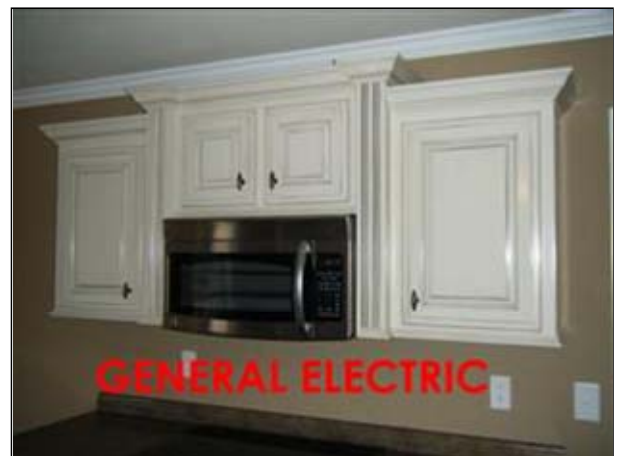
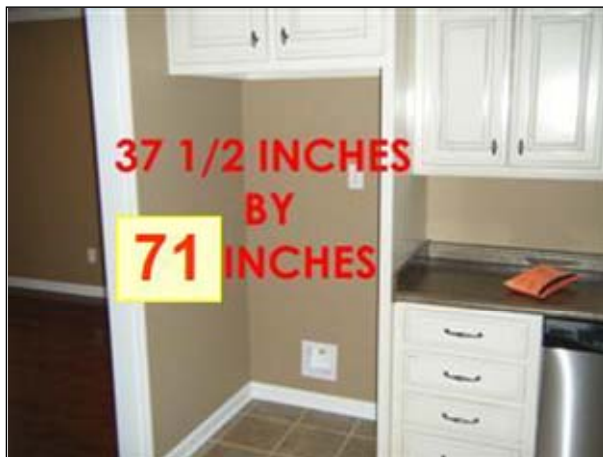
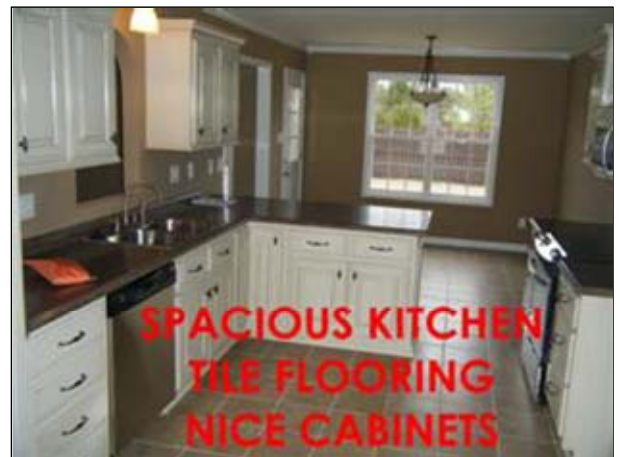
1. The kitchen is well appointed, the appliance all work as the should and the cabinets and counter tops are secured.
2. The maximum refrigerator for this kitchen is 37 1/2" by 71 Inches.

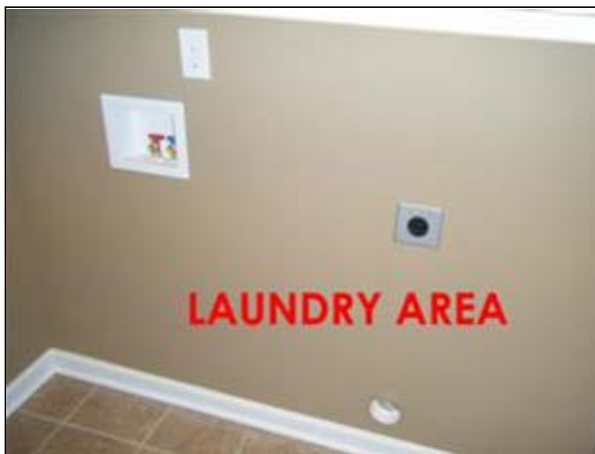
6.0.B Picture 1

1. I found no issues with the laundry room. You may wish to hang a mirror over the sink in the laundry room.

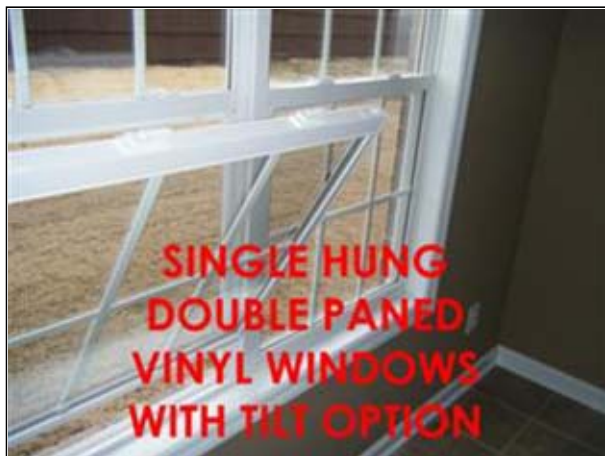
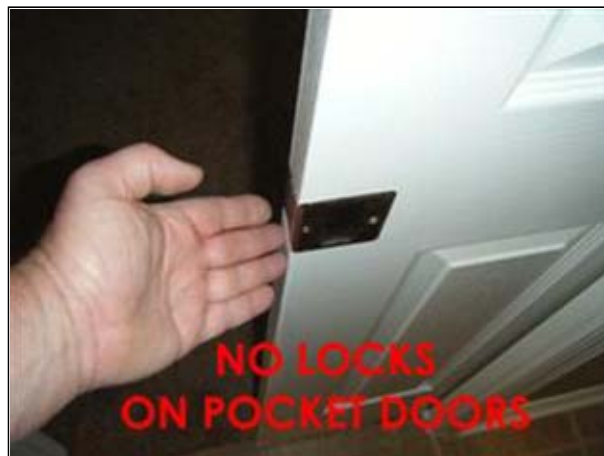
1. The interiors are well appointed, the carper, tile and hardwood all appear to be installed in a manner consistent with good workman ship.
2. The windows are double paned, single hung and have the tilt option for easy cleaning. They are constructed of vinyl.
3. The pocket doors are not lockable. These doors are located at the entrances to the bathrooms and you might want more privacy.

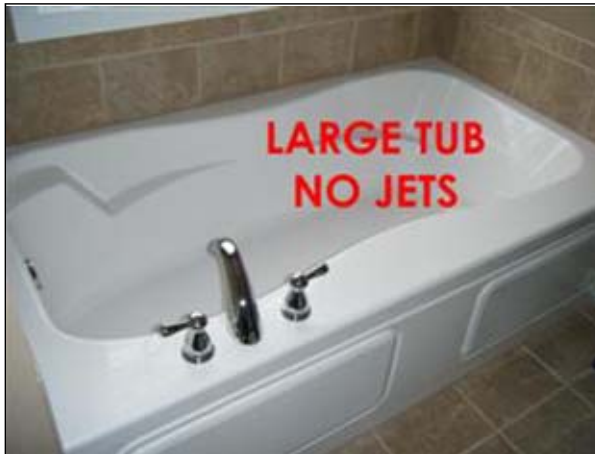
8.0 Picture 1

1. The bathrooms are in good condition and i found no fault.

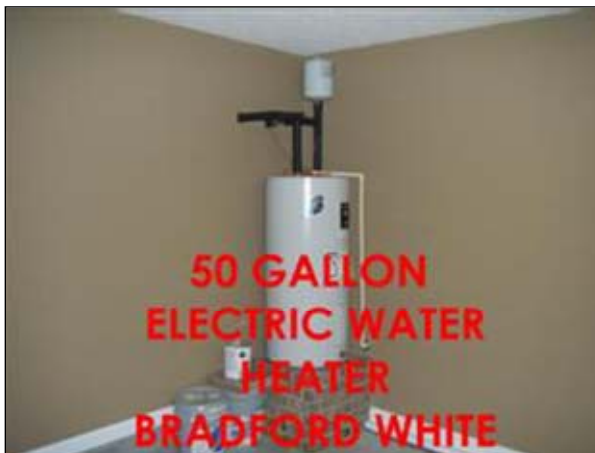
10.0 Picture 1

1. The plumbing appears to be in good condition and i found NO leaks, NO drips, No issues.

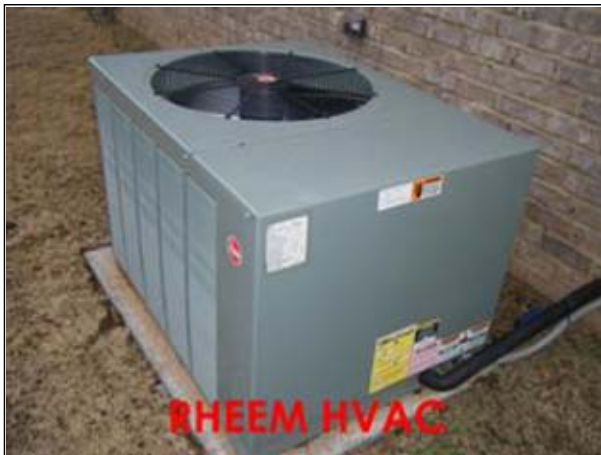
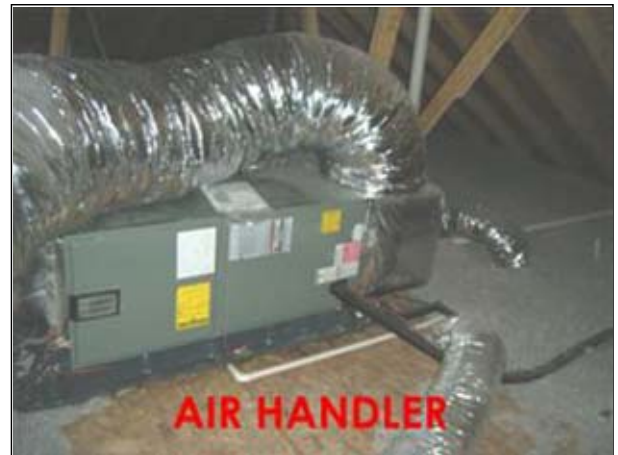
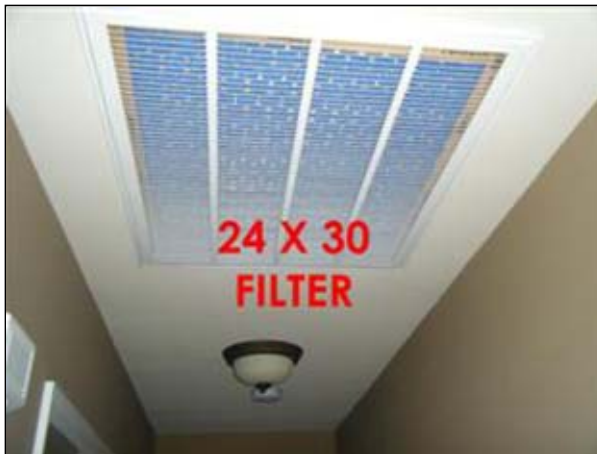
- 1. The HVAC system is in good condition and i found no issues with any of the components. The air handler in located in the attic and is drained as it should be.
